Report on Earthquake Sikkim Nepal Border-2011

3. Glimpses of Damages as seen through Field Visit:

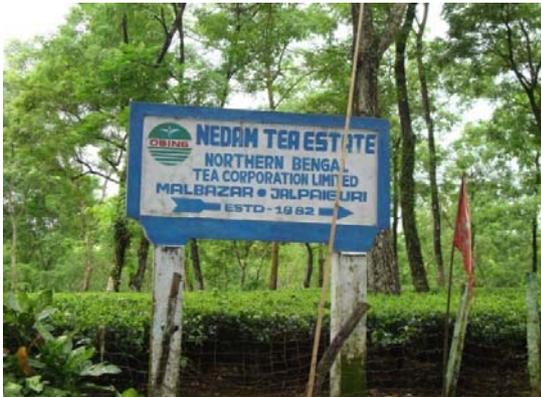
Nedam Tea Estate is a Gram Sansad of Rangamati Gram Panchayat of Mal Block. The only casualty occurred because of the said earthquake is in this tea garden.

Ranjit Nagesia alias Anjit son of Jugani Nagesia about 18 years of age died due to wall collapse during the earthquake. He was returning to his home during the earthquake. The said wall was damp and cracked at several places.

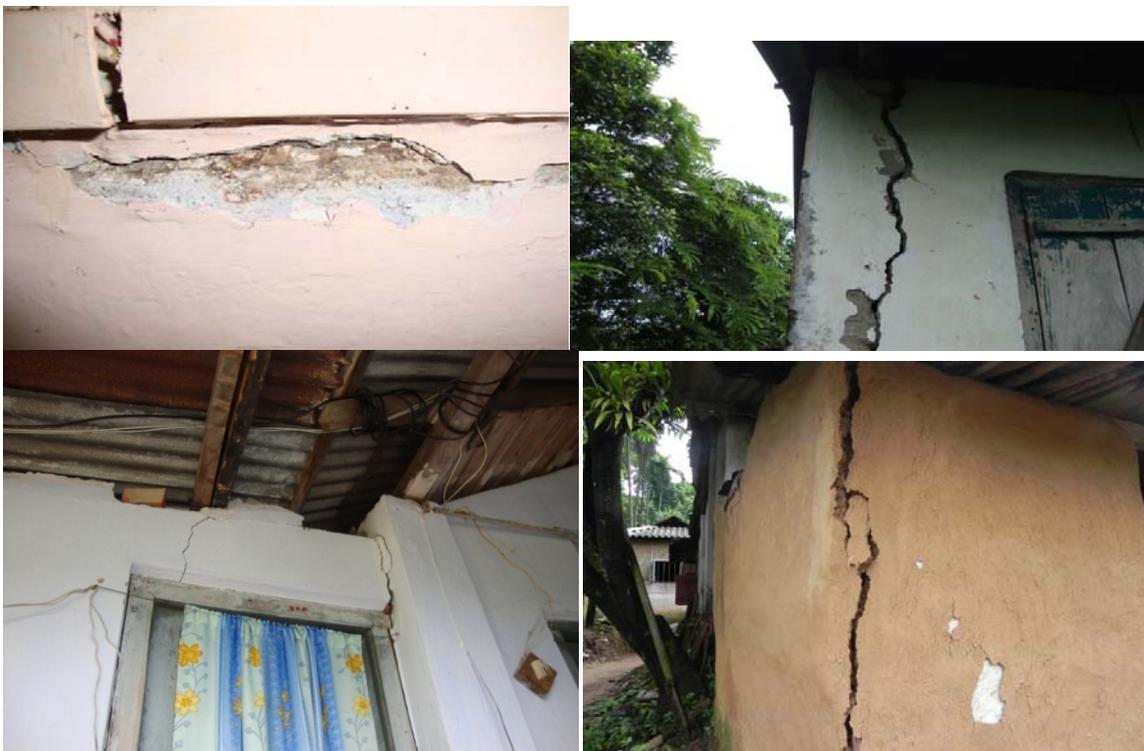
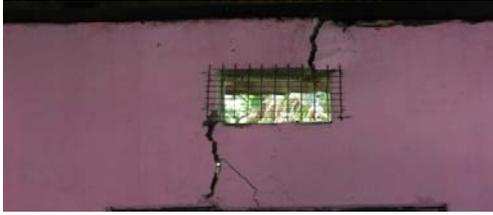
Cracks have been developed in several houses in the labourer quarters. Some of the houses had vertical as well as horizontal cracks in the walls as shown in the pictures below.

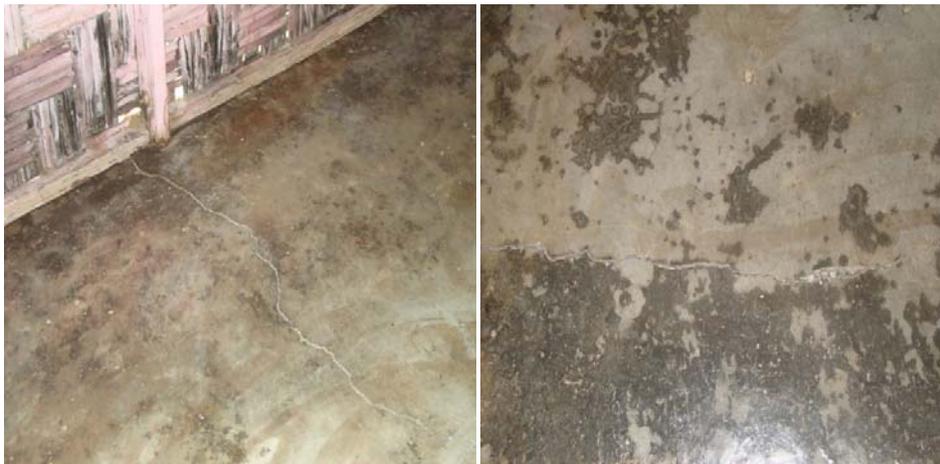
In two houses cracks have been occurred in the floor.

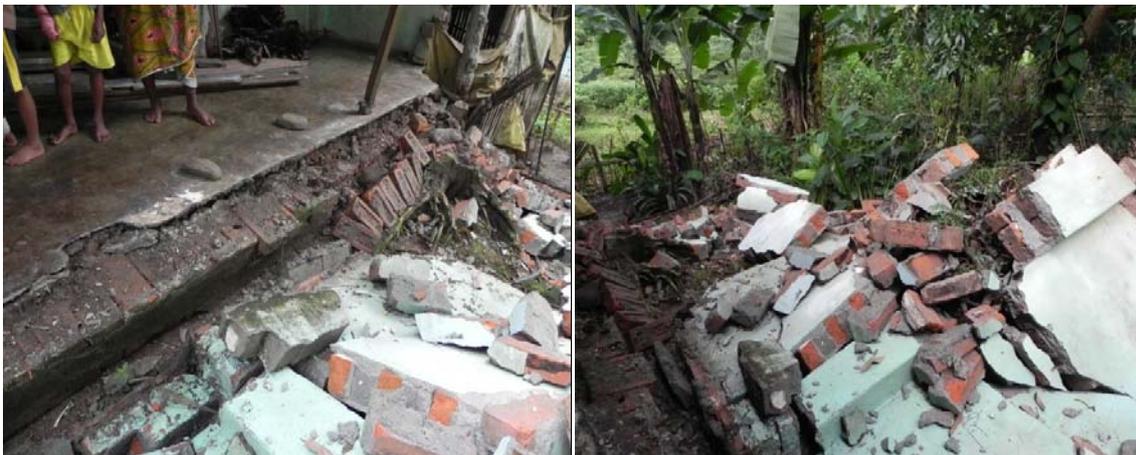
In Matiali tea garden under Matiali block at Samsing cracks have been developed in many houses. One wall of each of the two houses was collapsed during the incident.

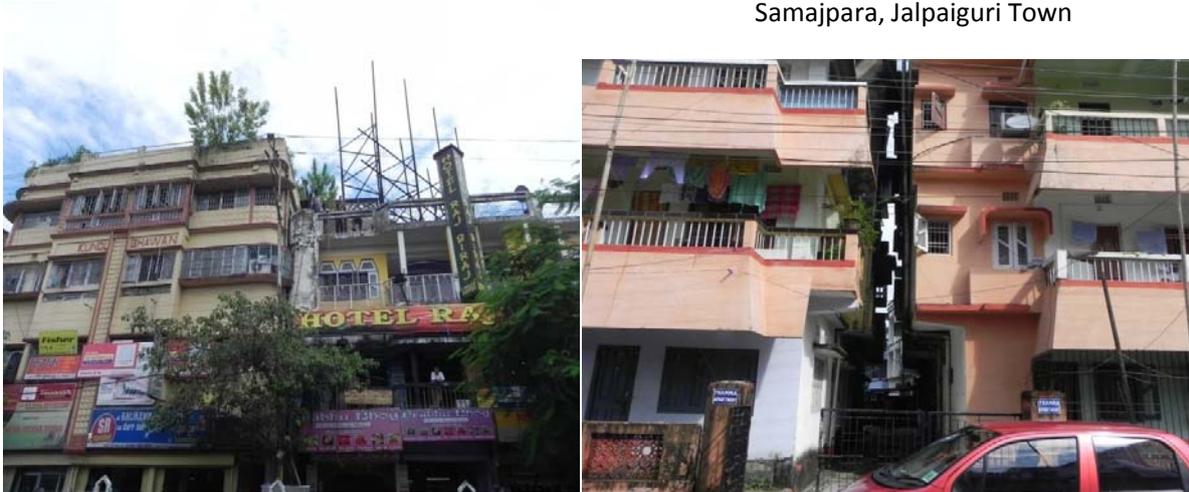
Samajpara, Jalpaiguri Town

In the urban areas of Jalpaiguri, Siliguri there are reports of cracks in the residential buildings. But two cases of partial subsidence of multi-storied buildings have been noticed. In each cases one building is seen leaning against the adjacent building.

- a) Keeping free space between the adjacent buildings should be made mandatory while constructing buildings.
 - b) Soil testing should be made compulsory while constructing multi storied buildings,

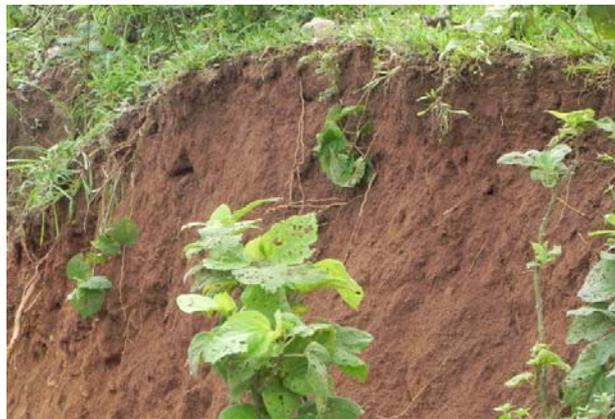
A case of landslide could be noticed in Nedam Tea Estate, Mal.

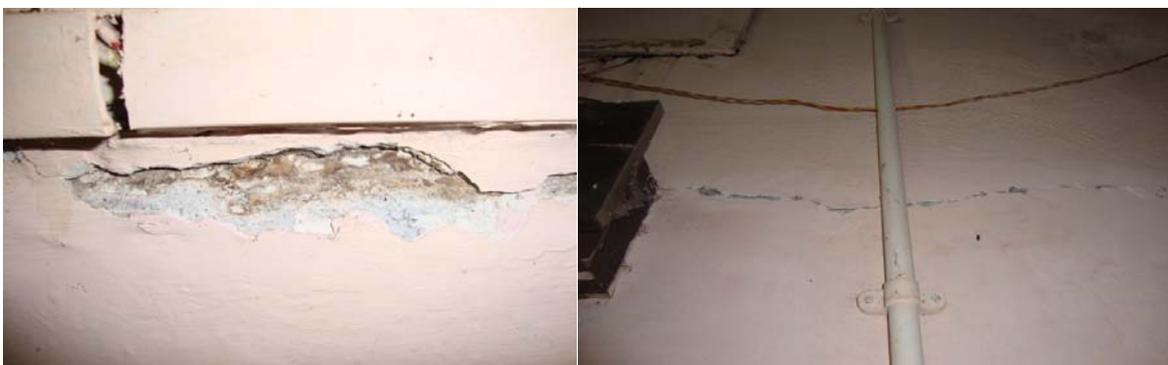
Government buildings: Several cracks have been observed in the **office of The SDO Mal**. The building is owned by Jalpaiguri Zilla Parishad.

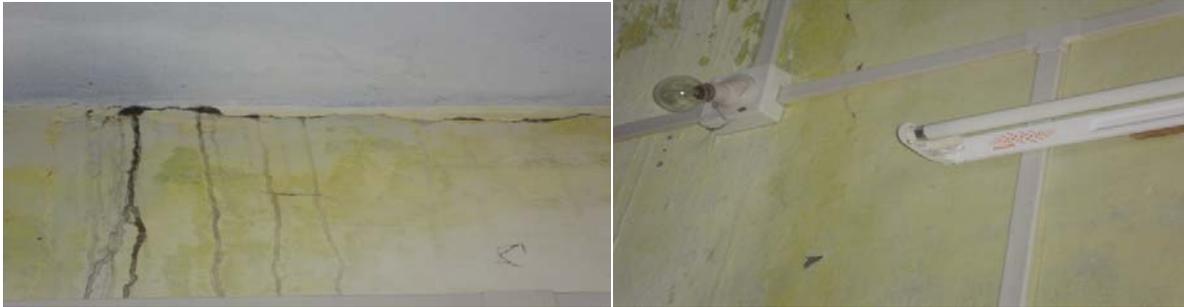
A newly constructed large hall adjacent to the office chamber of BDO, in the **office of the B.D.O, Matiali** has developed cracks in each of the four walls.

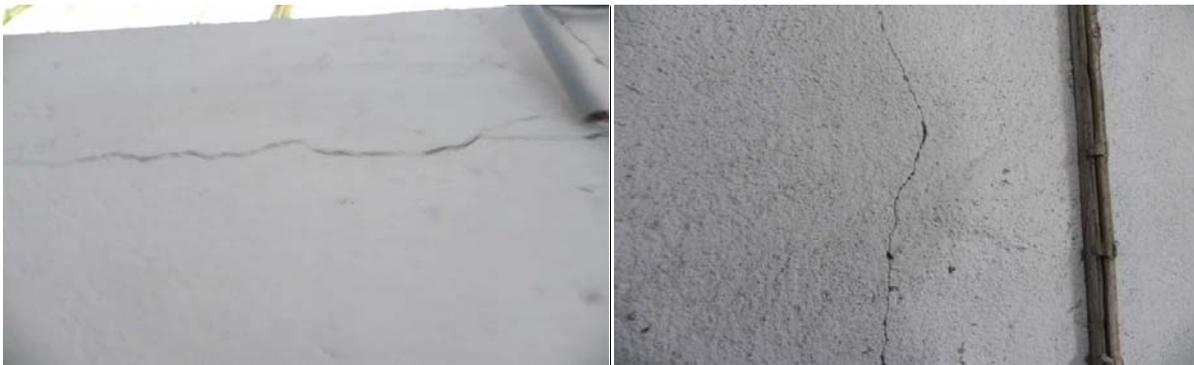
The Collectorate building of Jalpaiguri district developed a number of cracks in different positions.

Some of the cracks are shown in following pictures,

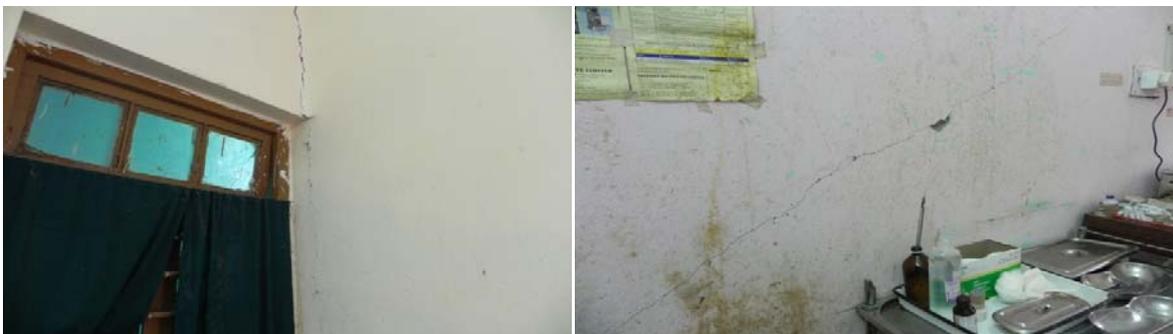
Health Services: Among the public utility buildings health centres have been damaged to a large extent. Mangalbari BPHC in Matiali block was visited on 21st September, 2011. A number of cracks have been found in the rooms where the patients are being kept after admission. The residential quarters of nursing staff have also been damaged badly.

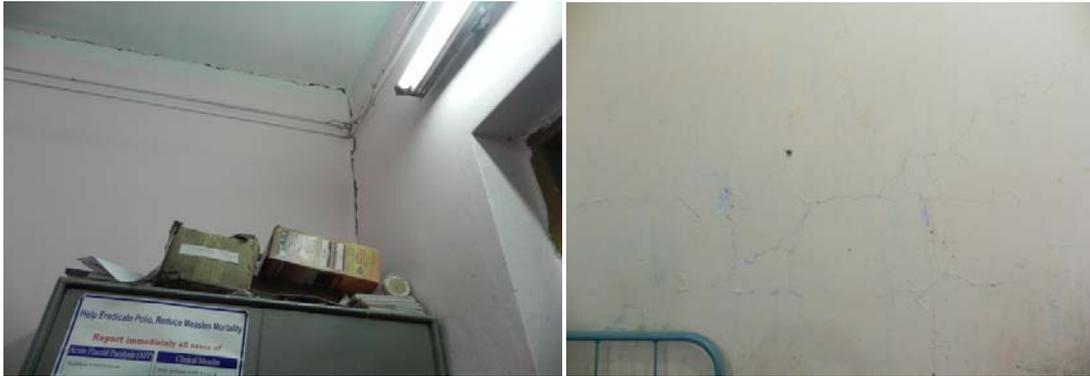
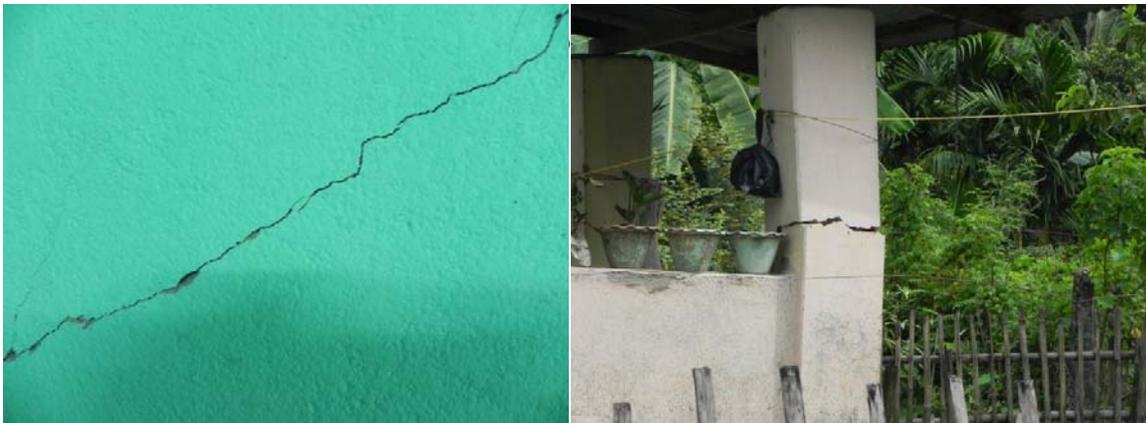
Inside Mangalbari BPHC

The structural condition of the BPHC where the indoor patients are kept is so vulnerable that the Doctors are scared to admit patients and are also in a dilemma how long they would be able to continue the medical treatment.

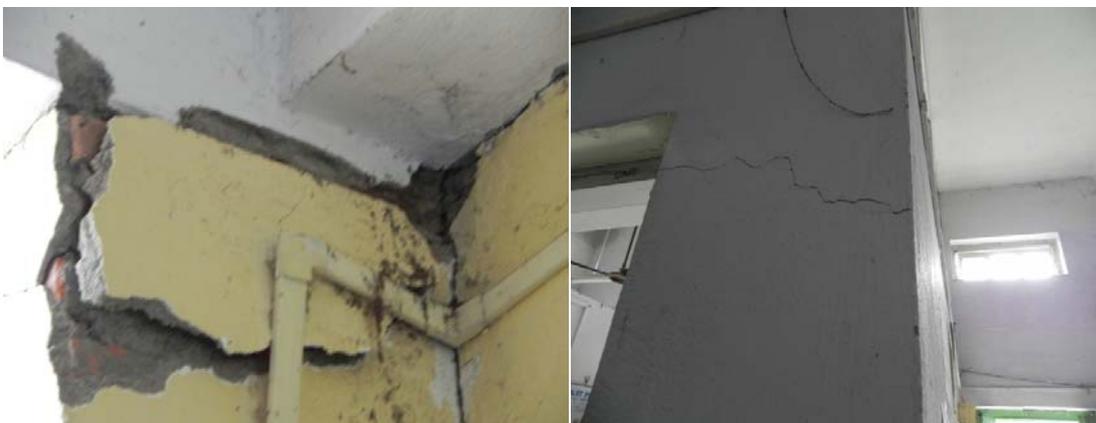
Jalpaiguri District Hospital was visited on 22nd September, 2011. Several cracks of various types have been noticed in a new building. Some of the cracks can be seen in the following pictures. It is heard that the old buildings are not damaged.

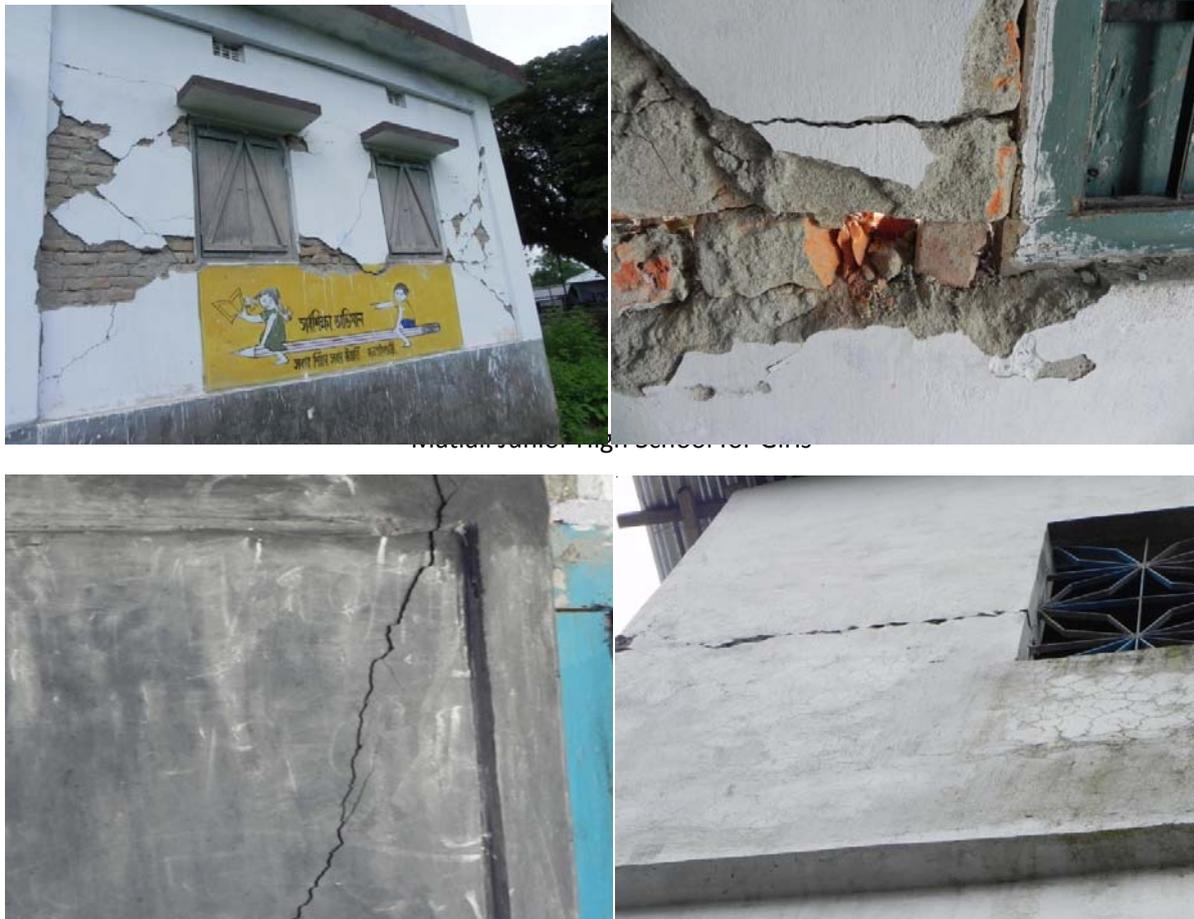
Educational Institutions: Matiali Junior High School for Girls' is one of the hardest hit buildings by earthquake in Mal subdivision.

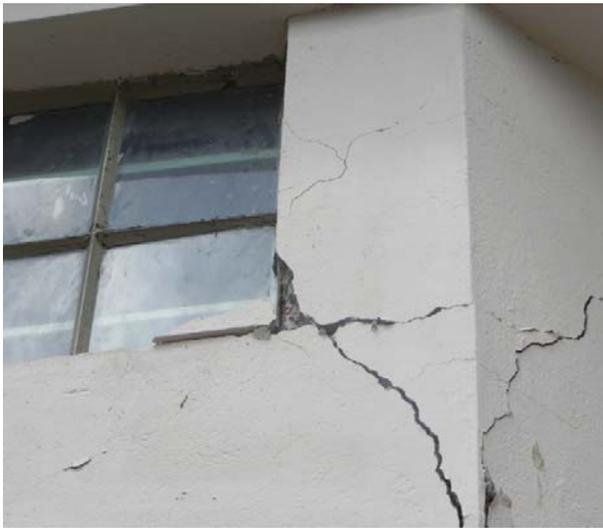
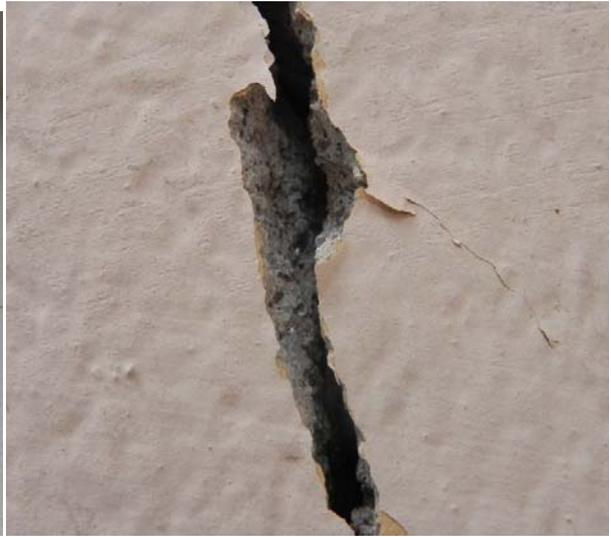
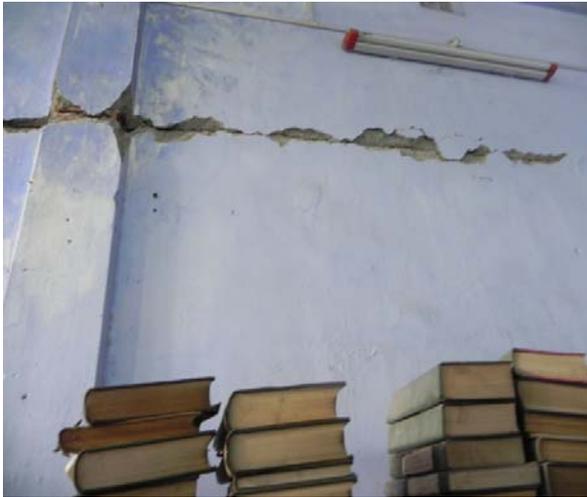
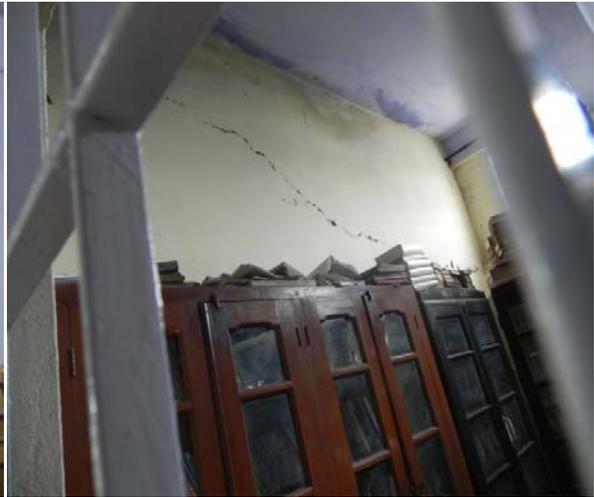
In Siliguri town, the library building of Siliguri College is also very badly damaged. The building was inaugurated in the year 2000. As expressed by Prof. M Karanjai, Principal of the College, damages did not occur in older buildings.

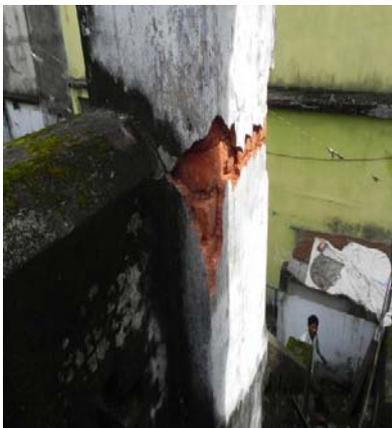
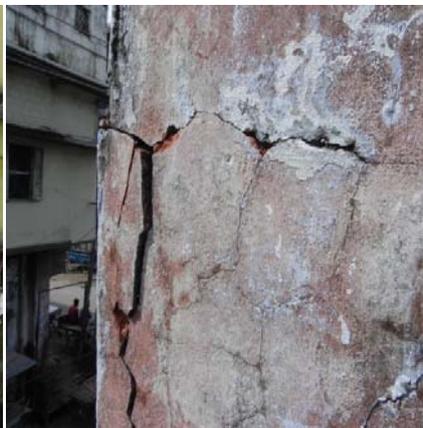
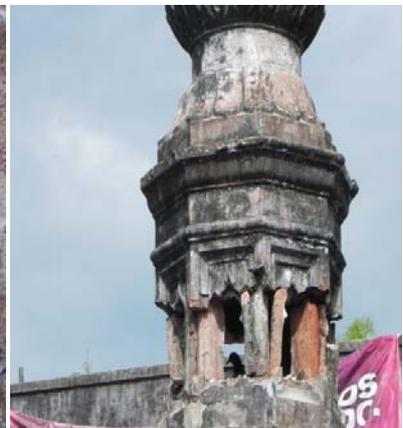
Religious Places: Dinbazar Chota Masjid in Jalpaiguri town was severely damaged by earthquake. Pillars from different sides, portions of the minarets as well as boundary walls were badly damaged and are in precarious condition. If broken, those debris would hurt the people on the road.

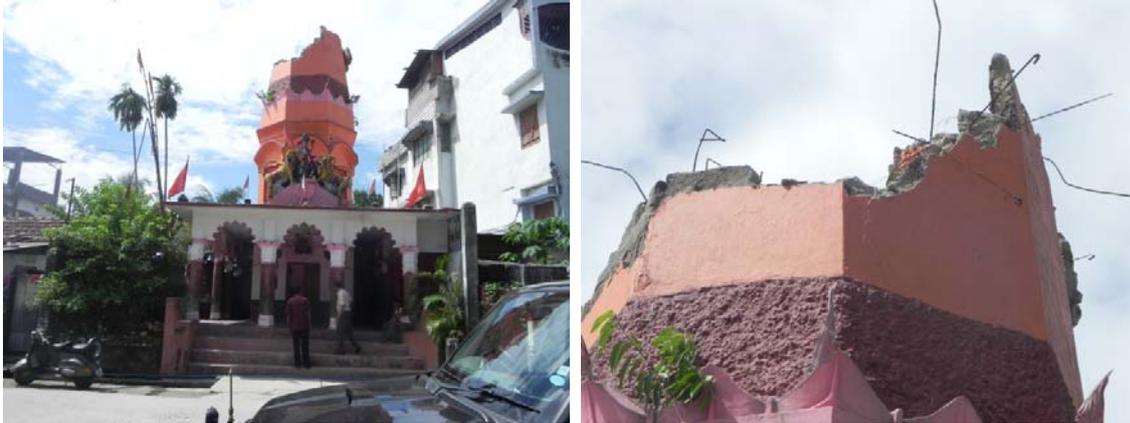
The topmost dome of a Shiva temple at ward no-20 in Siliguri town was broken down and caused destruction of roof of the adjacent house.

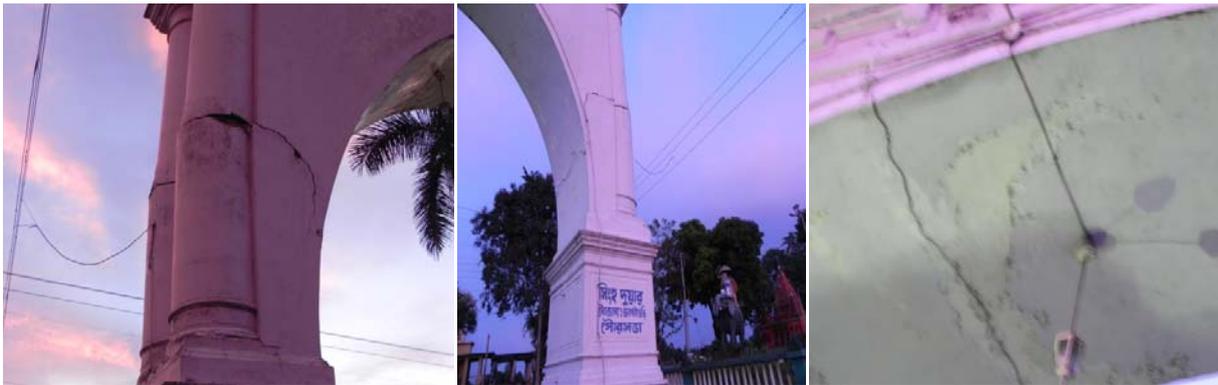
Damage to the archaeological structures: 'Singha duar' can is regarded as gateway to the Jalpaiguri town. The structure was damaged very badly in each side as a result of shaking on 18th Sept.

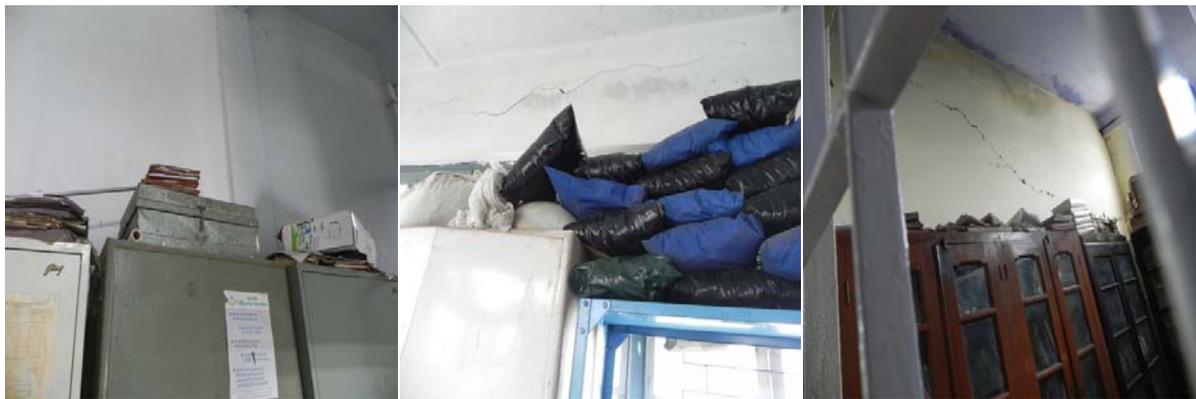
It was reported from many offices including the hospitals that things kept above the almirahs fell down on the floors. In addition to that the no furniture is fixed to the walls. The pictures below would better illustrate the point. So, result of shaking would have been more number of casualties had it occurred during office hours.
